PHASE I INSPECTION REPORT

**WALLACE CREEK BASIN
WALLACE CREEK DAM
CLINTON, MONTANA
MT-1158**

**MORRISON - MAIERLE, INC.
CONSULTING ENGINEERS**

APRIL, 1981

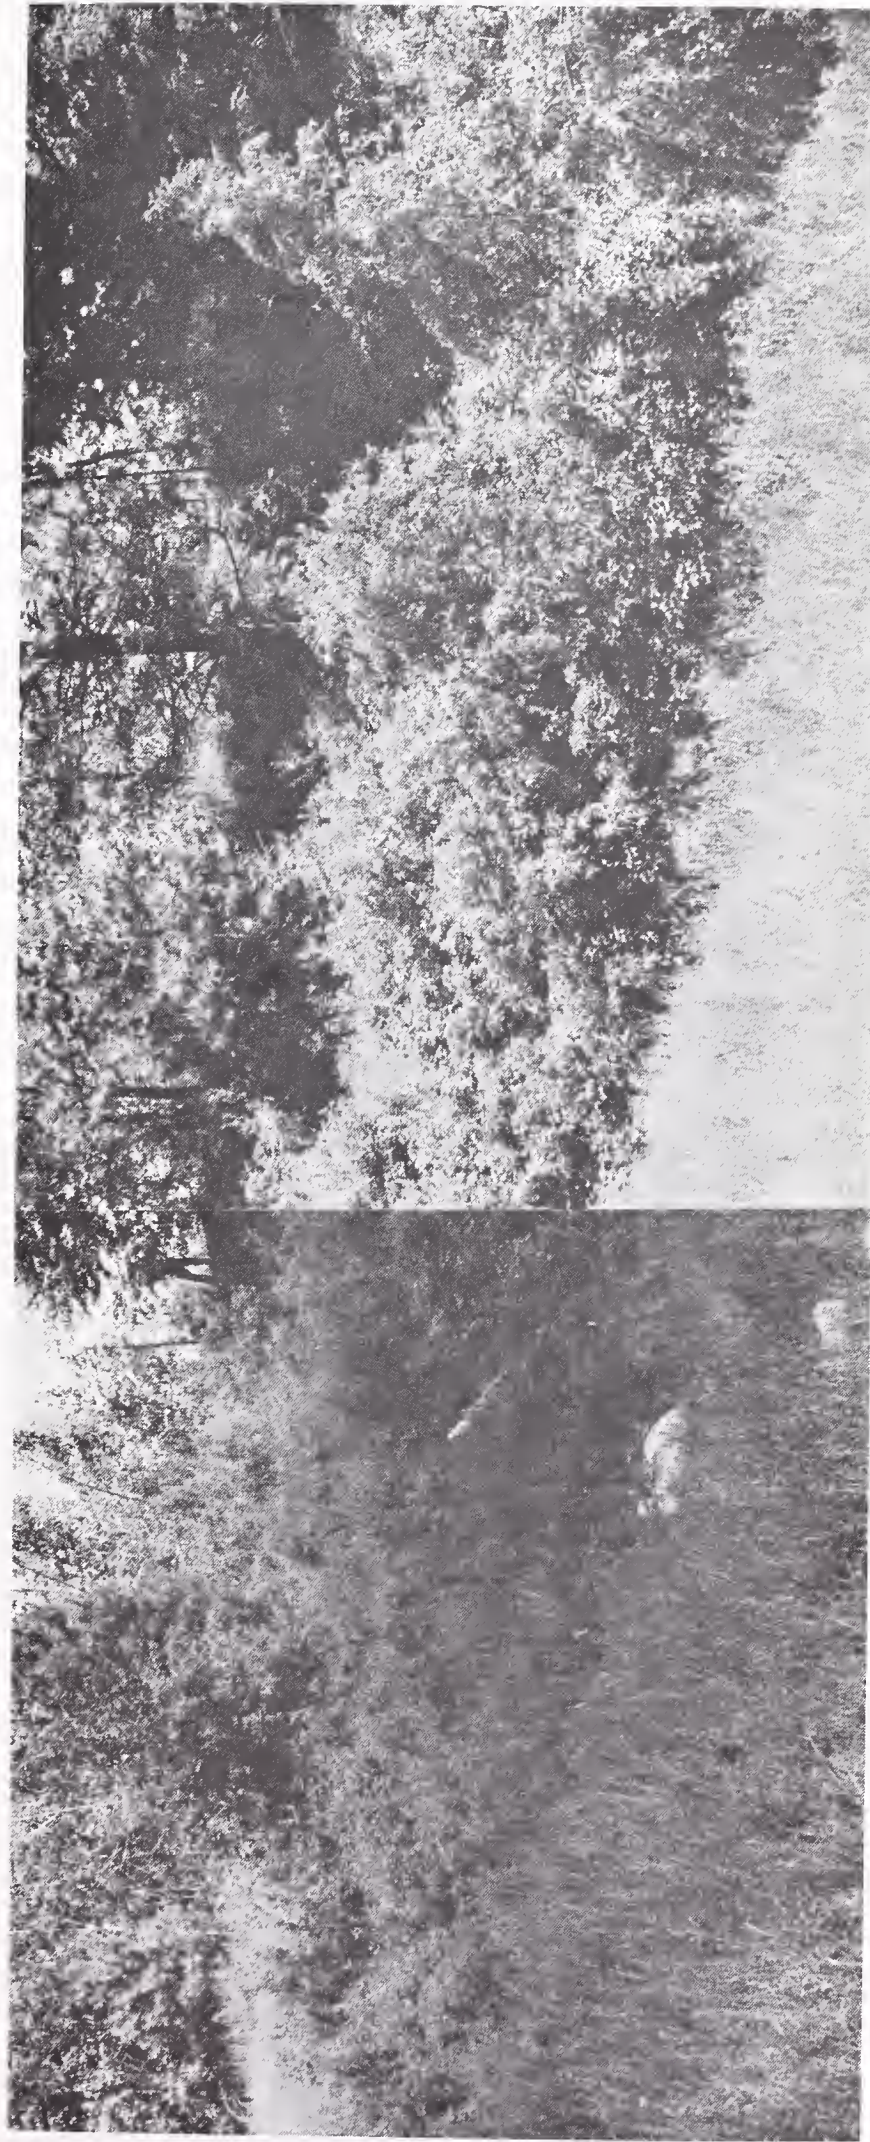
The composite earth and rock fill embankment does not exhibit any evidence of differential settlement, misalignment, erosion, rodent burrows or embankment failure. The upstream and downstream faces of the embankment are heavily vegetated with large bushes and mature trees and could be described as "forested" in most spots. The upstream face is not protected by riprap or other selected material but it is not wave eroded.

Photo 5 Downstream Face of Main Embankment Area.

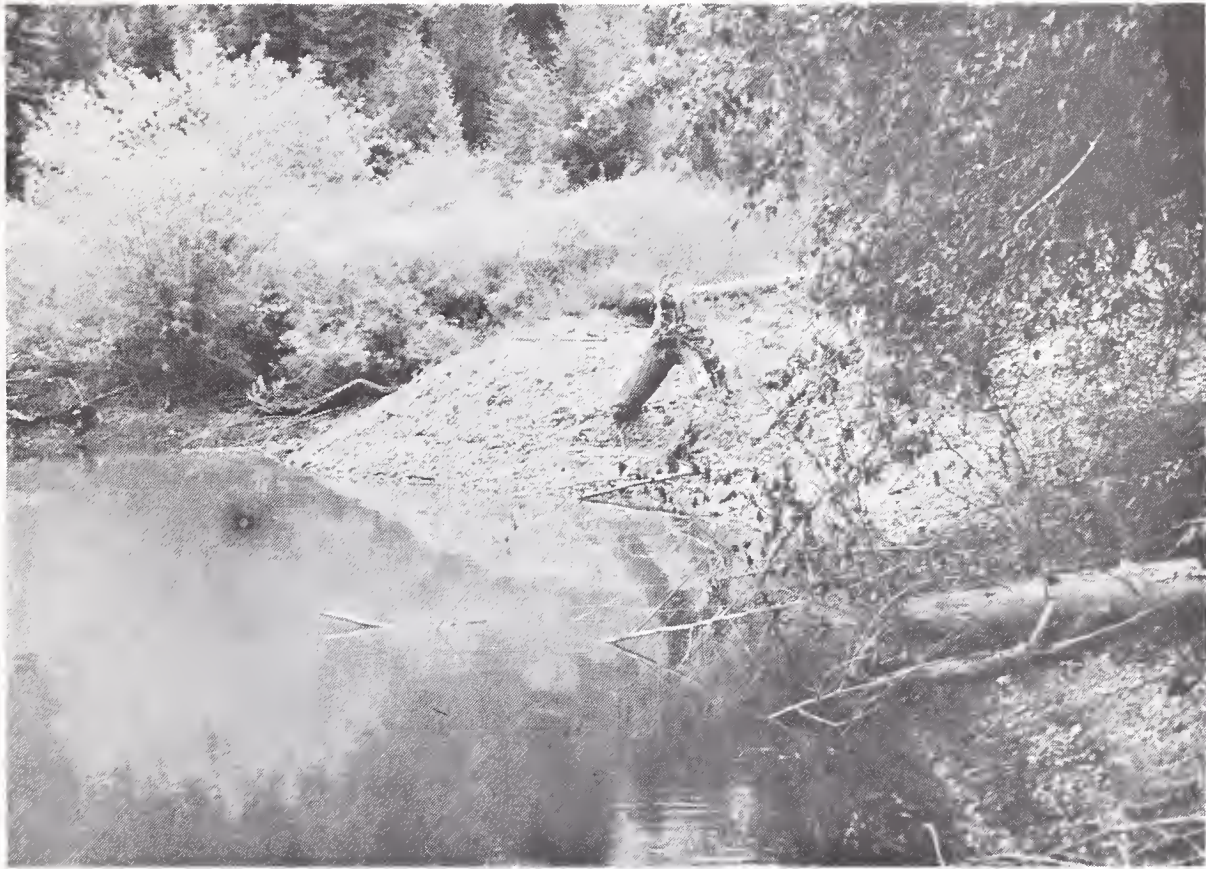
Photo 7 Spillway Entrance.

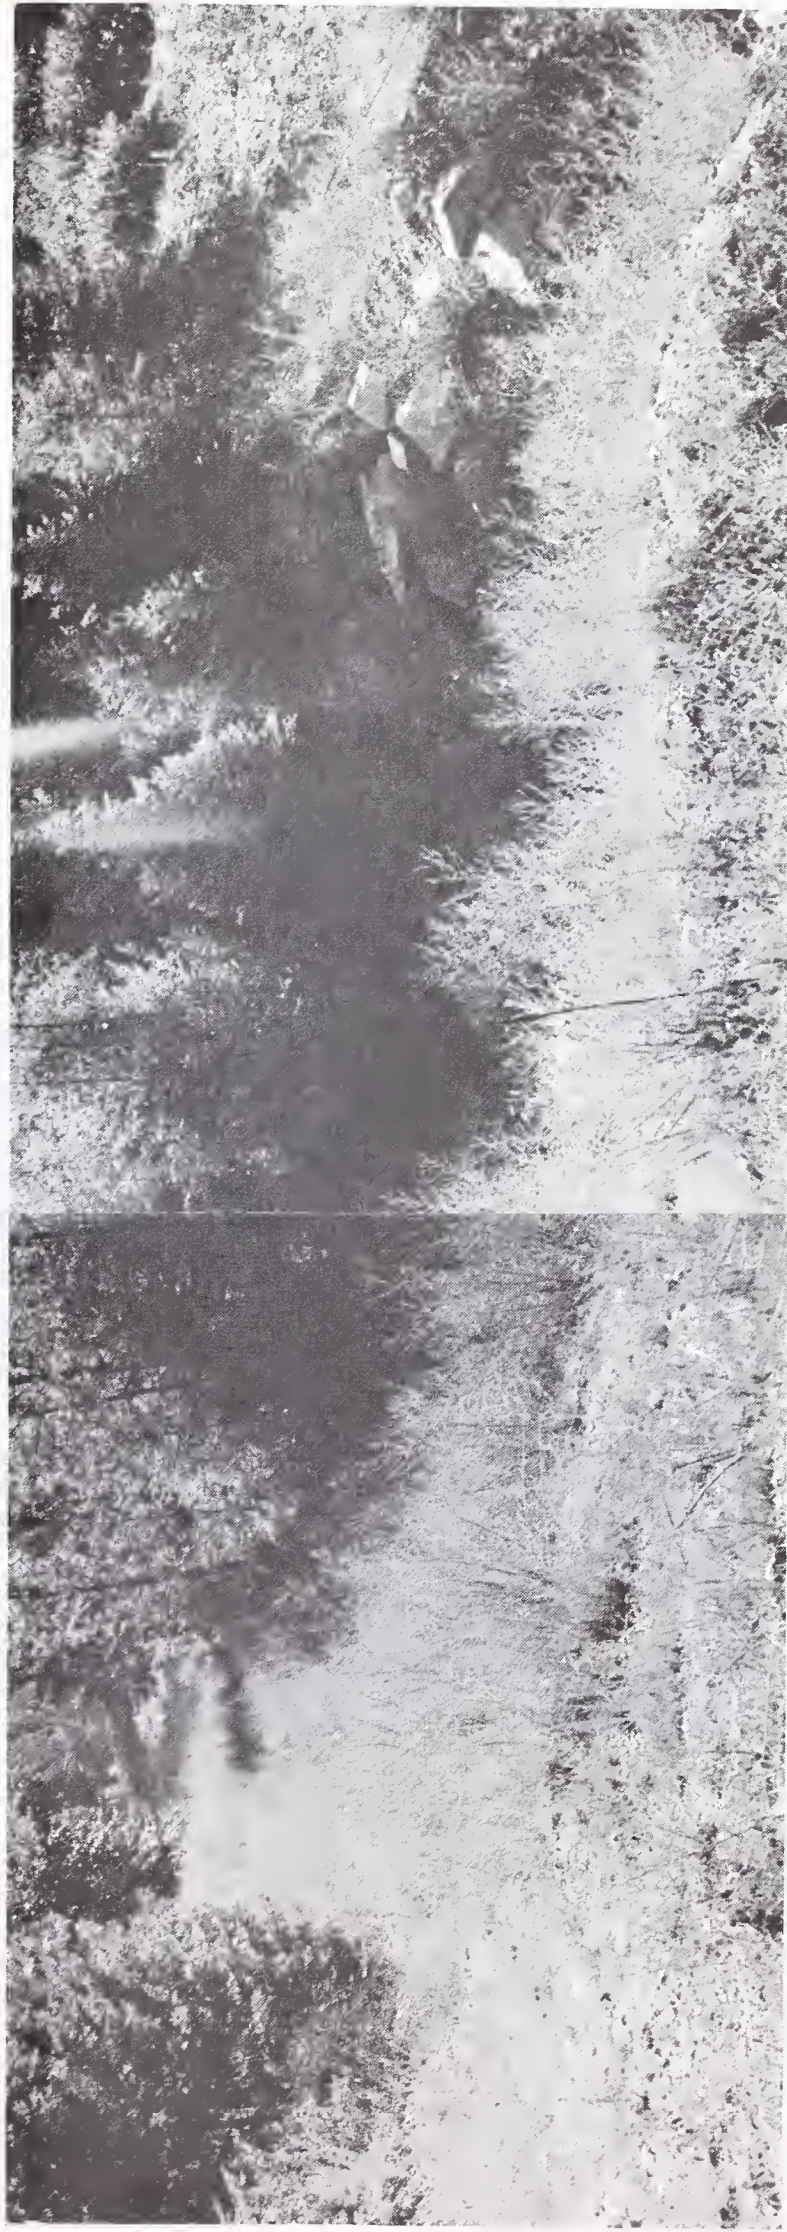
The spillway chute from the reservoir to the culvert section is in fair condition with a heavy growth of weeds in the channel (Photo 9). In the left bank area (facing downstream) there is a moderately thick stand of fir trees and on the right bank is a dike with some brush and a few small trees on it extending from the dam. The shoreline of the reservoir is heavily timbered and brushy with quite a lot of debris in the near shore area particularly at the spillway entrance (Photo 7). There is no log boom

Photo 9 Spillway Channel Looking Upstream Toward Reservoir From
the Control Section.

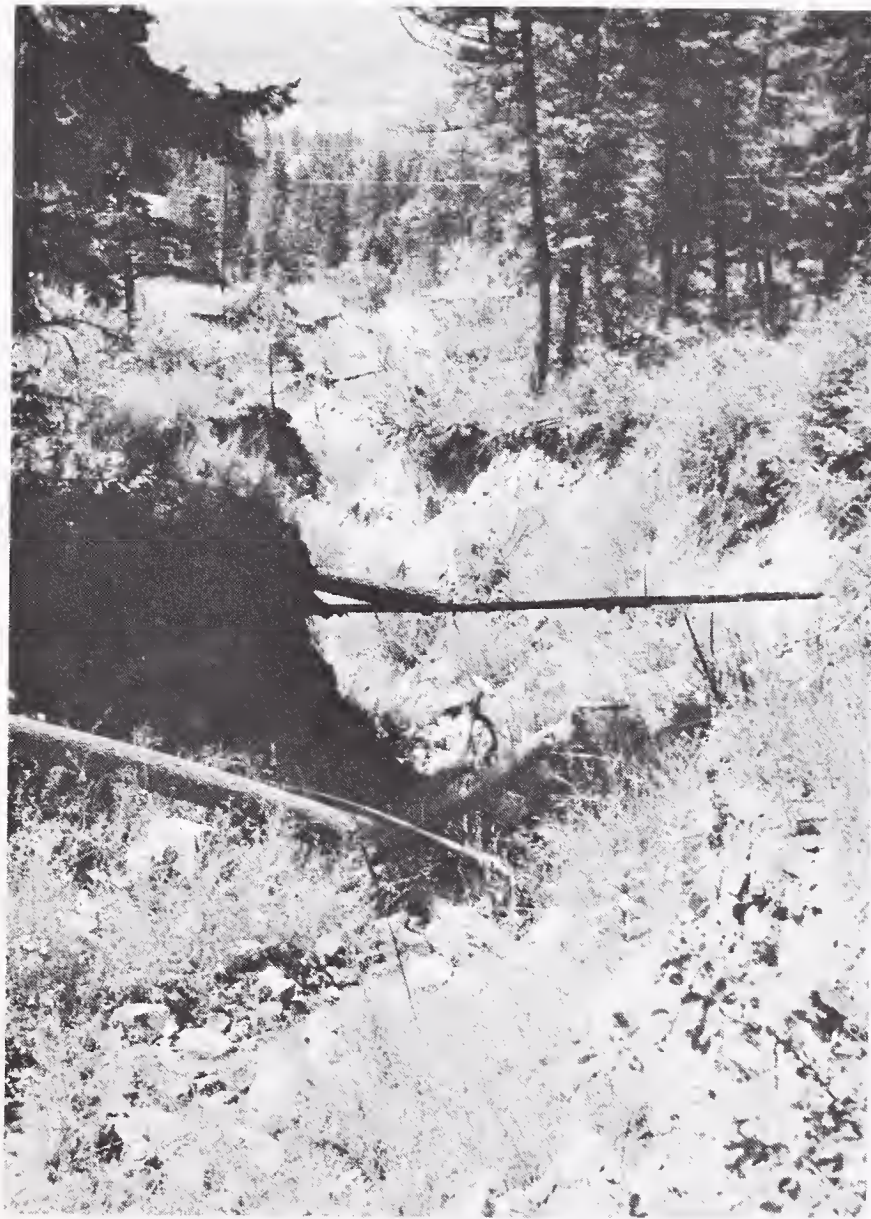
Photo 10 Spillway Dishcharge Channel Looking Downstream From Seep Area.

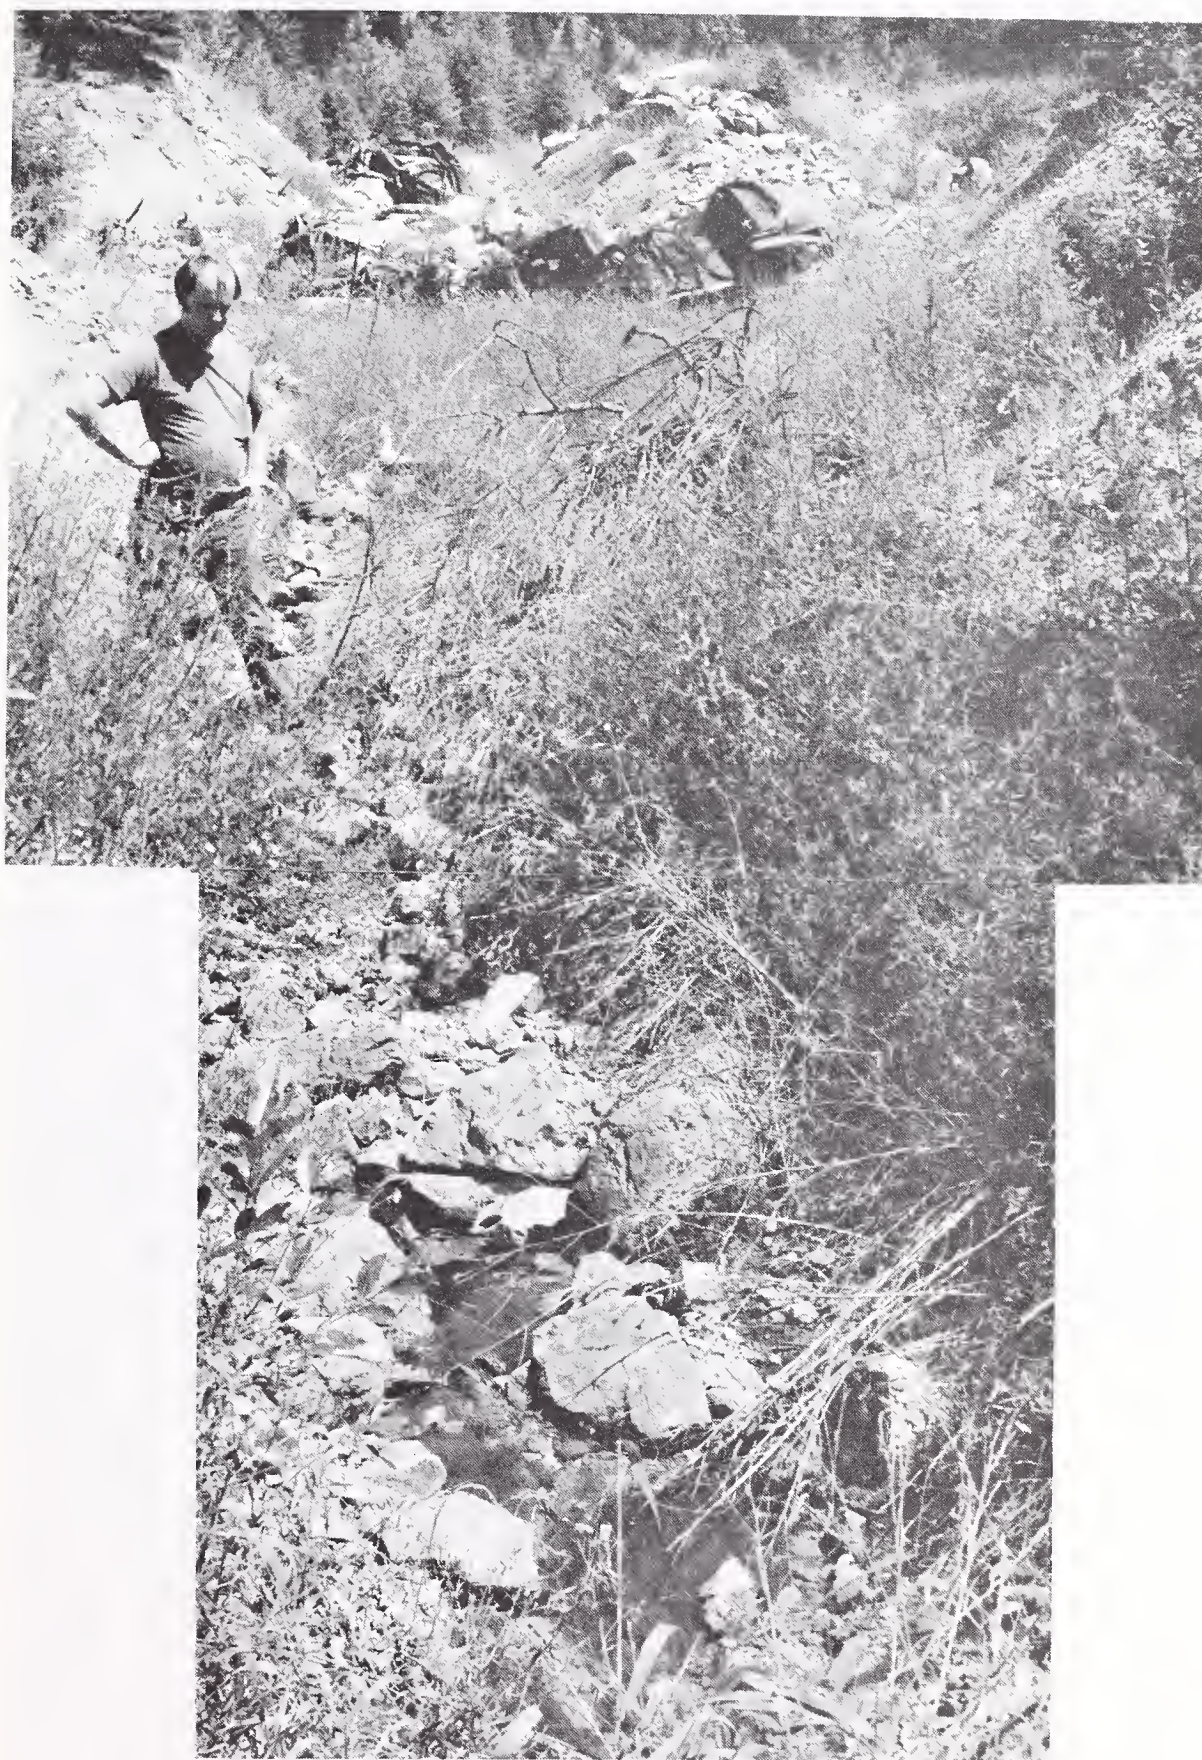
A free-flowing spring discharging 50 to 100 gpm was observed in the spillway channel about 100 feet downstream from the culvert section. The highest appearance of water in the channel below the spillway on July 17, 1980 was at an elevation of 3873.0 feet, about the same elevation as the top of the massive granodiorite bedrock which outcrops further downstream in the channel. A second seep, with approximately the same flow, surfaces on the bedrock of the spillway erosion channel about 150 feet further downstream from the first seep. Evidently, seepage is moving either through the base of the landslide material on top of the bedrock or through a rubble zone or fractured weathering zone on the bedrock. The bedrock apparently controls the elevation of seepage discharge at the base of the landslide material. The owner states that seepage losses make it impossible to maintain the level of stored water in the reservoir during periods of low inflow.

A seep or spring flow, estimated to be 50 to 100 gallons per minute, emerges from the bedrock in the spillway channel about 100 feet downstream of the dam. A second seep emerges similarly about 150 feet further downstream. The seeps are apparently in the foundation material or fractured bedrock and are clean and free-flowing. There is no indication of erosion or piping at the seep areas.

Photo 11 Seep Area in Bedrock in Spillway Channel 100 feet Below Control Section.

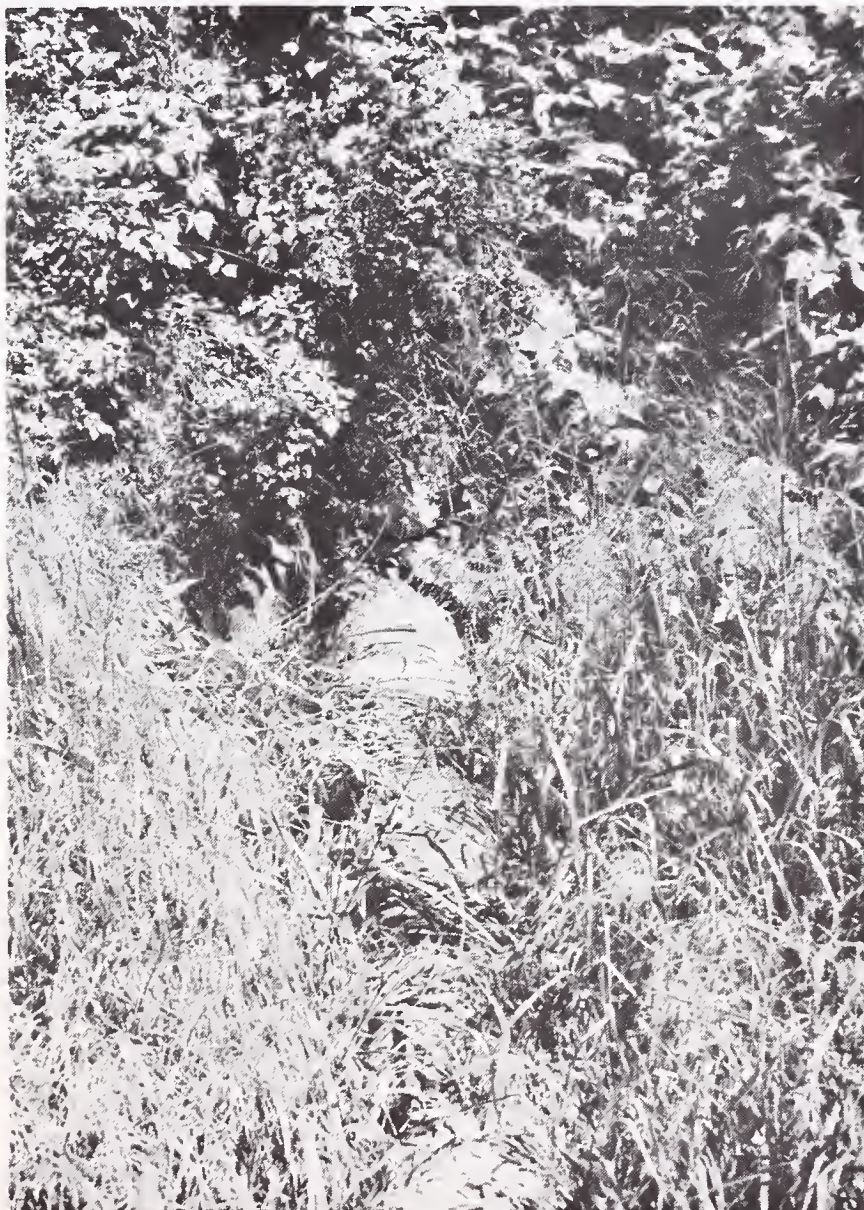
An estimated one to two gallons per minute was observed seeping through and under the 18-inch diameter concrete outlet pipe. The water was clear and there was no noticable erosion at the outlet.

Photo 13 Outlet at Toe of Embankment. 12-inch Steel Pipe Inside 18-inch Concrete Pipe.
